# Management Plan

## for Antarctic Specially Protected Area No. 162 MAWSON'S HUTS, CAPE DENISON, COMMONWEALTH BAY, GEORGE V LAND, EAST ANTARCTICA

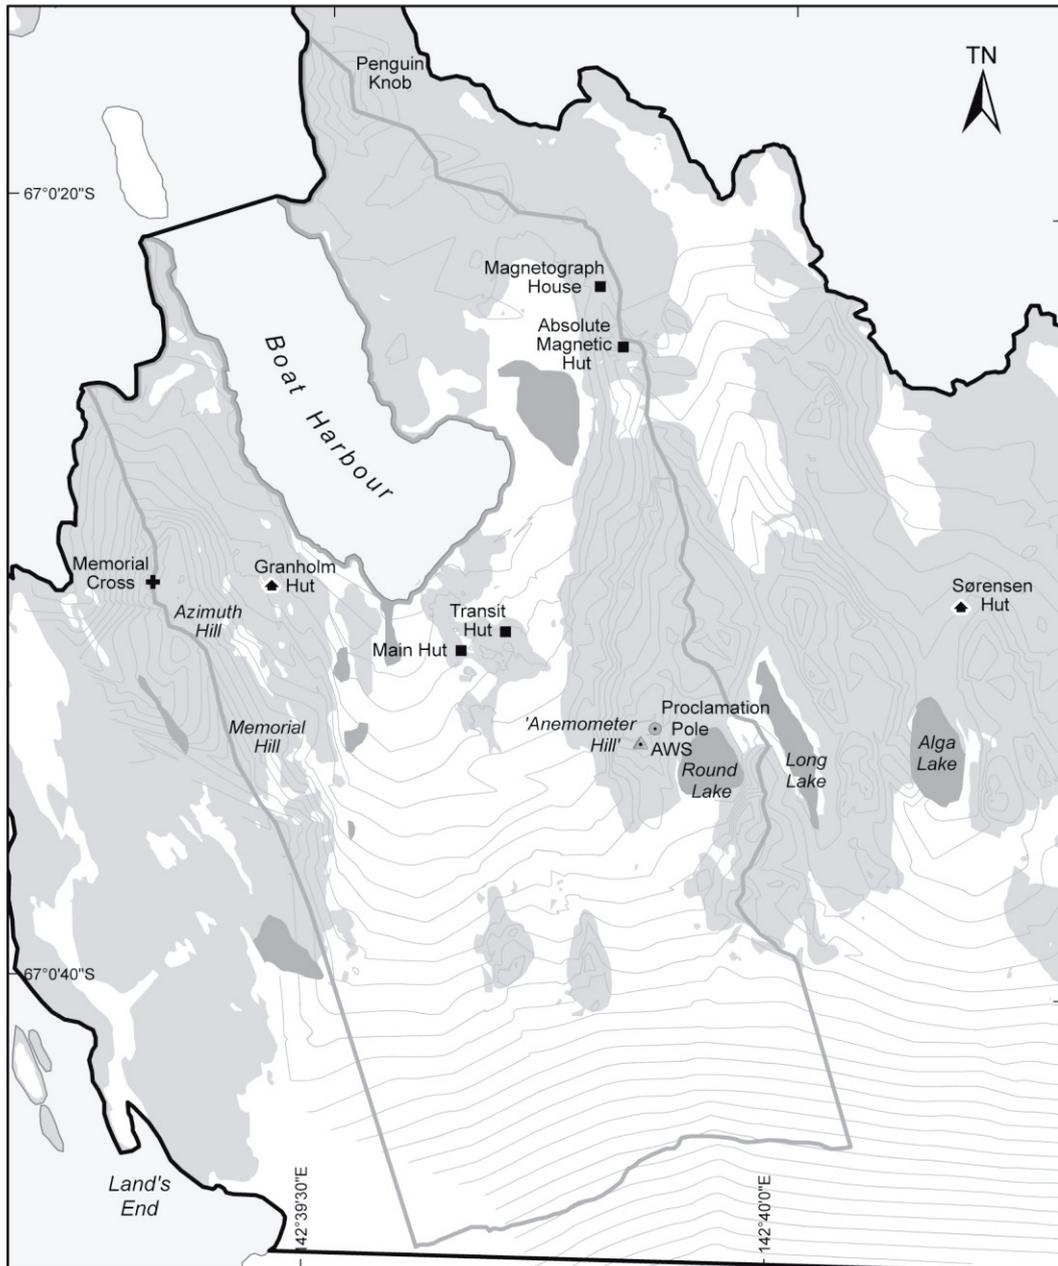
# Map B Cape Denison Visual Protection Zone

The map shows the boundaries of the Visual Protection Zone and indicates the position of significant historic artefacts, including the four Australasian Antarctic Expedition huts, the Memorial Cross, and Anemometer Hill, the site of the BANZARE Proclamation Pole.

The visual catchment of Mawson's Huts and the Memorial Cross is of particular importance within the Cape Denison cultural landscape. In order to protect the landscape setting and 'sense of place' of Mawson's Huts, a Visual Protection Zone is defined within the ASPA. To preserve these values, no new structures should be built within the Visual Protection Zone. The Visual Protection Zone is illustrated on Maps A and B and is generally defined as the area enclosed by the western and eastern ridge lines of the valley containing the historic structures. The boundary extends from the coastline (67°00'24.9"S, 142°39'14.3"E) and runs southeast along the western side of the westernmost ridge to the ice plateau (67°00'46.8"S, 142°39'37.2"E); northeast along the edge of the ice plateau to 67°00'43.9"S, 142°40'5.6"E; north-northwest between Round Lake and Long Lake to 67°00'33.7"S, 142°39'59.8"E; then as far as Magnetograph House (67°00'20.3"S, 142°39'46.6"E); and then northwest along the eastern side of the eastern ridge line to the sea (67°00'15.7"S, 142°39'28.2"E).

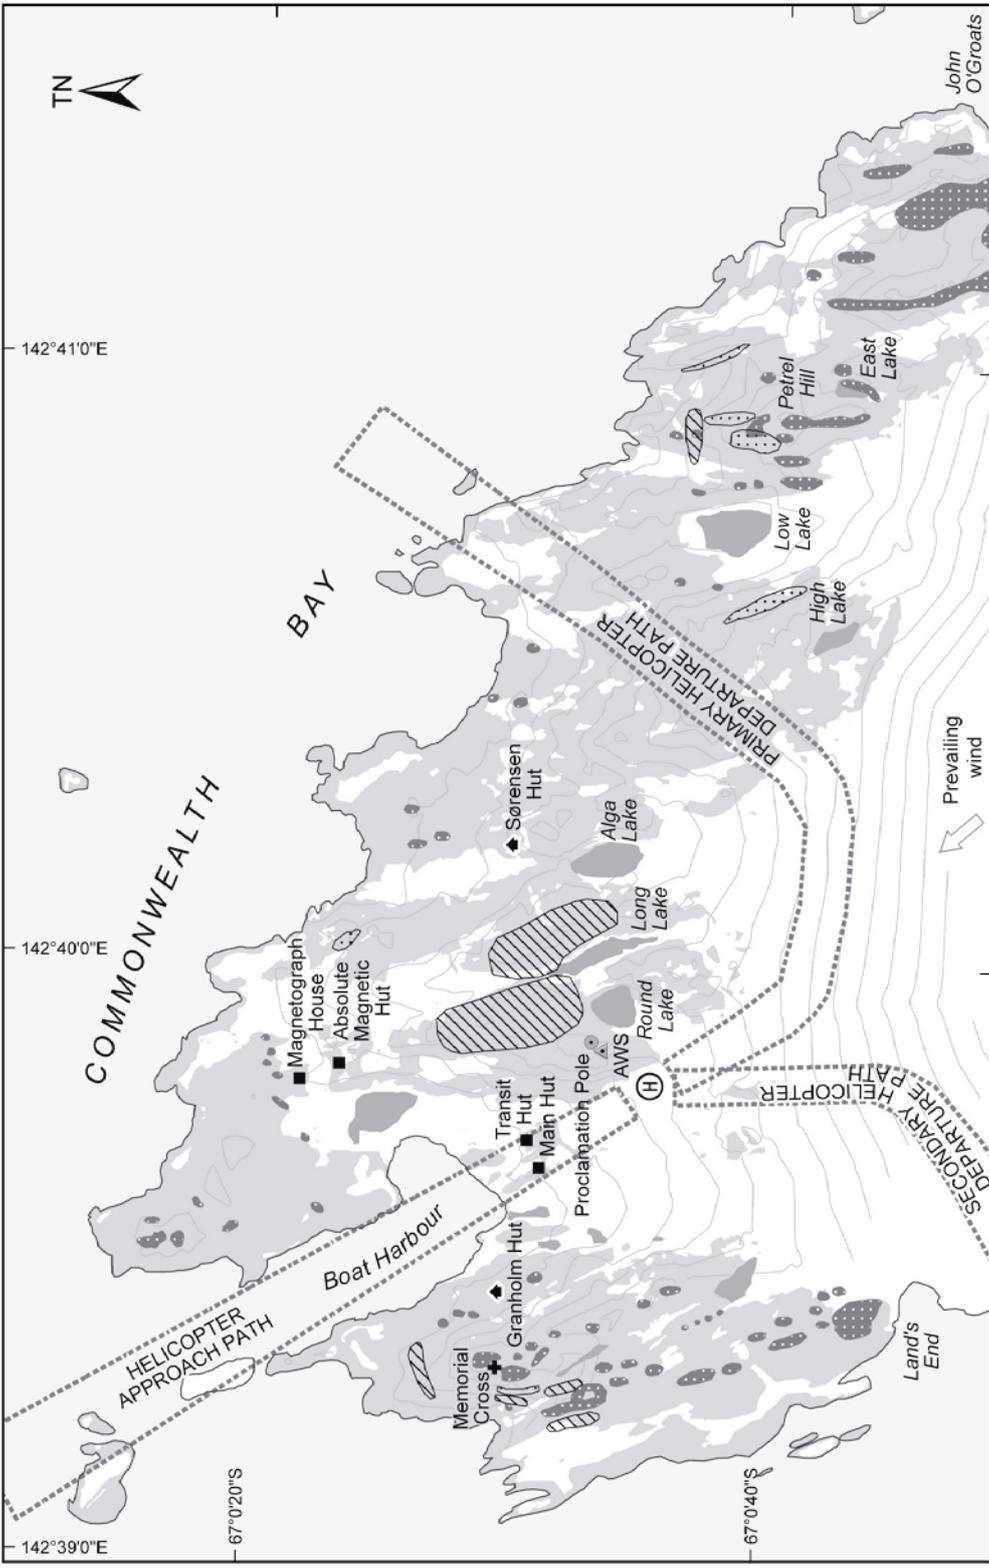
# Map C Cape Denison Flight Paths and Bird Colonies

The map indicates the approaches, departures and landing site for helicopters, as well as the location of bird colonies in the vicinity.

Sea, land and air access to Mawson's Huts is difficult due to the rugged topography and climate of the area. Sea ice extent and uncharted bathymetry may constrain ship access up to 10nm or more from the coastline. Access can be gained either by small watercraft or by helicopter, although attempts to land are frequently hampered by heavy seas and prevailing north-westerly or katabatic winds. Boat landings can be made at Boat Harbour and due north of Sørensen Hut. The helicopter landing site (67°0'30"S, 142°39'19"E) and approach and departure flight paths are indicated on Map C.

Helicopter operations have the potential to disturb breeding and moulting wildlife. To minimise disturbance to seals and nesting birds at Cape Denison during the summer months, helicopters should only land at the site indicated on Map C and approach and depart in accordance with the flight paths indicated on the map. Departure paths have been selected to avoid wildlife concentrations as much as possible. Use of a single-engine helicopter is preferable; however twin-engine helicopters may be used with due regard for the potentially greater disturbance to wildlife. The presence of seals and the breeding cycle of birds nesting in the Area are charted at Appendices B(i) and B(ii); twin-engine helicopter operations should be avoided during weeks that birds are hatching eggs or raising chicks (late October to early March).
